Belzona Coats Entry Drive Rollers With A Low Friction Coating

Industry: General Industry
Application: SHM-Solids Handling Machinery

Customer Location: South Wales, UK
Application Date: August 2020

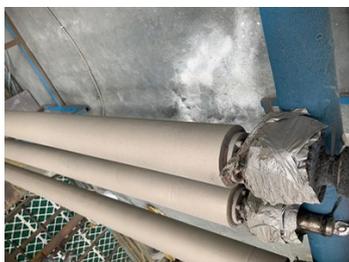
- * 1 - Grit blasted substrate ,
- * 2 - First coat Belzona 1341 ,
- * 3 - Second coat Belzona 1341 ,
- * 4 - Completed bundle of rollers ,

This is a unique application and has been undertaken by an experienced local coatings contractor for at least five years. Rollers are grit blasted and degreased, with Belzona 1341 applied as a two coat system in accordance with the IFU document. This application is also applied in accordance with a modified version of Belzona System Leaflet SHM-12.
