# Belzona Pump repair in a Sugar Factory

Industry: *Sugar* Customer Location: *Switzerland*  
Application: *CEP-Centrifugal Pumps* Application Date: *August, 2020*  
Substrate: *Steel*  
Products: *\* Belzona 9111 (Degreaser) ,*  
*\* Belzona 1111 (Super-Metal)<span style="white-space: pre;"> </span> ,*  
*\* Belzona 1391T ,*  
*\* Belzona 5811 (Immersion Grade) ,*

Repair and coat a Nash vacuum pump in the Sugar Industry.

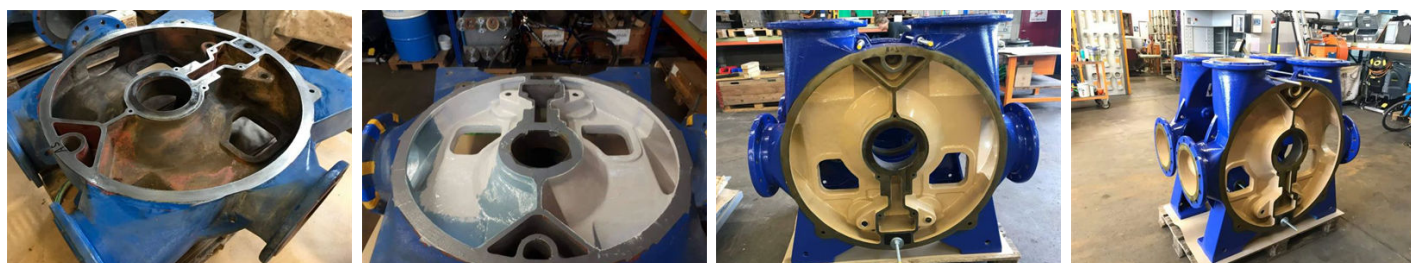
*The long running time and high loads resulted in wear damage and corrosion on the housing. The flanges on the housing were washed out by installing the wrong seals.*

- \* 1: Damaged Pump ,
- \* 2: Coating Internals of the pump. ,
- \* 3: Completed Internals of pump. ,
- \* 4: Completed Pump ,

The application was carried out in accordance with Belzona system leaflet CEP-3
