Penstock Outer Surface Coated with Belzona

ID: 8383

Customer Location: Hydro Power Plant, TURKEY
Application Date: September 2020

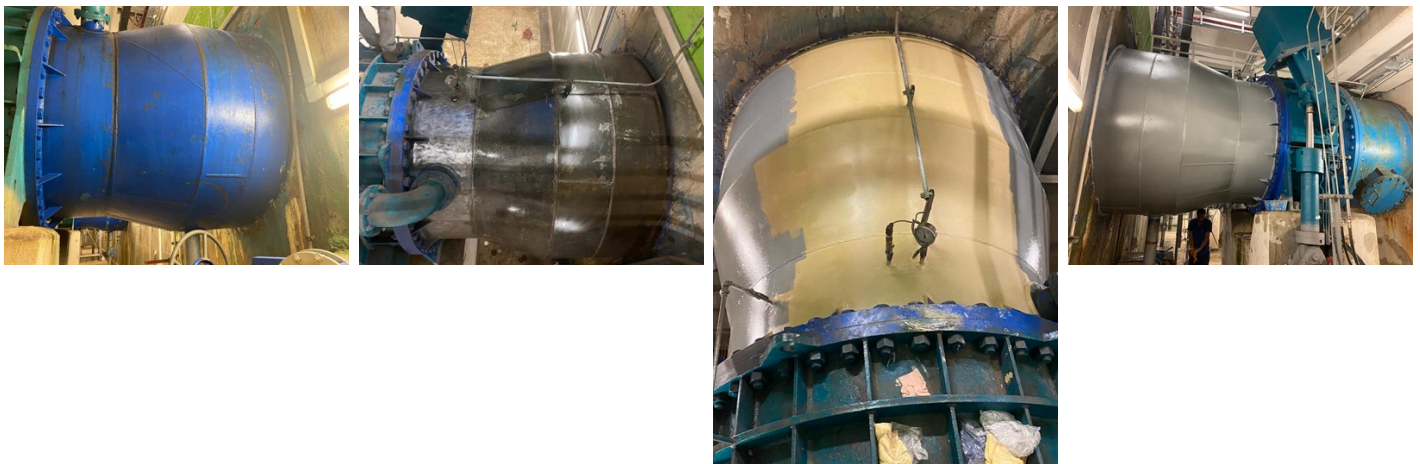
Photograph Descriptions

The outer surface of the penstock was constantly exposed to moisture. Previously painting swelled in a short time.

- * 1- Before surface preparation, painted surface ,
- * 2- After grit blasting ,
- * 3- When applying the second coat of Belzona 5831 ,
- * 4- End of application ,

The application was carried out in accordance with belzona System Leaflet TCC-03.

After a very good surface preparation, although the surface was moist during application, it was a successful application because the selected Belzona product was suitable for this.
