Belzona Tank Base Sealing In Service For Over 15 Years

Industry: Oil & Gas
 Application: TCC-Tanks and Chemical Containment Areas
 Substrate: Steel
 Products: * Belzona 3111 (Flexible Membrane) ,

Customer Location: Refinery, Croatia
 Application Date: 2005

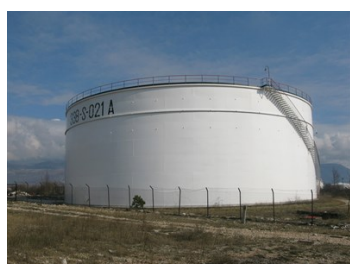
The conventional bituminous method with UV coating failed. Water was penetrating into the tank base. The customer demanded a permanent solution and demanded a 5 year guarantee.

- * 1. Tank before application. ,
- * 2. Application in progress. ,
- * 3. Protected surface 15 years after application. ,
- * 4. Tank after 15 years after application. ,

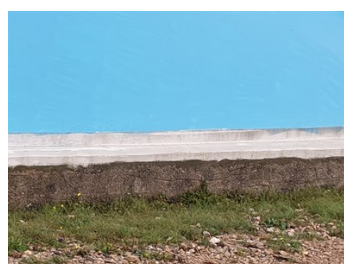
Annual visual inspections were carried out and the system proved to be flawless and permanent. The protection systems ability to

let water out but not to let water in provides longevity in service.
