BELZONA SEALS AIR COOLER COVER

ID: 8389

Customer Location: Ship Repair Workshop, Turkey
Application Date: September, 2020

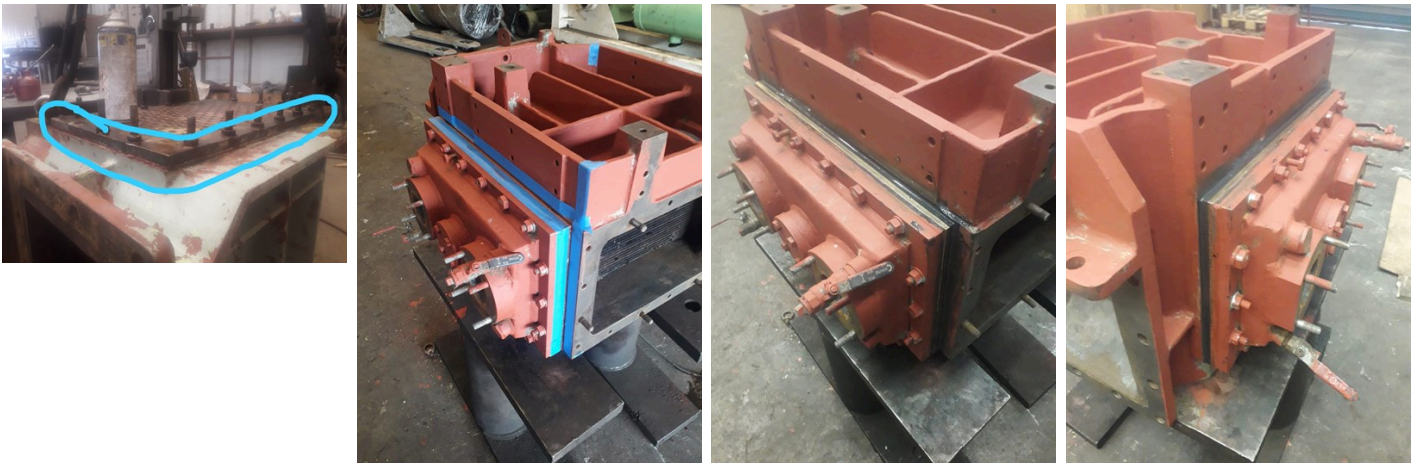
Photograph Descriptions

Due to the design of the Air Cooler, the gasket under the cover could not be changed. Over time and vibrations of Cooler, the deformed gasket lost its sealing and caused the performance of Air Cooler to decrease.

- * 1. Leaking Area ,
- * 2. Defining the application Area ,
- * 3. Filling between cover and case with Belzona 2211. ,
- * 4. After the application finished. ,

The application was carried out in accordance with Belzona Know-How System Leaflet HEX-13b. Application area preparation has done as abraded by hand tools in workshop. All surfaces were thoroughly cleaned. Belzona 2911 Primer has been applied as thin coat. Then the leaking area of Air Cooler Cover filled and coated with Belzona 2211 MP Hi-Build Elastomer to provide seal air and seawater.

Air Cooler did not allow the gasket under the cover to be changed due to its design. This made the missing seal difficult to repair. Belzona was the only alternative that could seal from the outside to withstand vibrations.
