Belzona distributor's oven helps for quick return to service

ID: 8392

Industry: Chemical & Petrochemical
Application: TCC-Tanks and Chemical Containment Areas
Substrate: Steel
Products: * Belzona 1391T,

Customer Location: Bratislava, Slovakia
Application Date: 2019

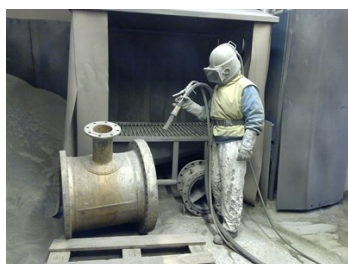
Erosion and Corrosion to the exchanger parts required repairing. Belzona 1391T's time until full service was 28 days in 20°C so post curing was required.

- * 1. Customer needed to protect his parts of exchangers ,
- * 2. Blasting and cleaning ,
- * 3. Garage oven with remote temperature control ,
- * 4. Coating exchanger parts to post cure ,

After blasting and cleaning, the parts of exchangers were coated with Belzona 1391T. The application was performed in accordance with Belzona system leaflet TCC-5. The distributor had prepared an oven in a concrete garage with glass cladding insulation, with heating and remote temperature control. The coated equipment was placed in the oven. The temperature was raised so that the coating was heated to a minimum 50°C for 1 hour.
