Belzona Chocking Compound Stabilizes A Lathe

ID: 8393

Customer Location: *Malacky, Slovakia*
Application Date: *2020*

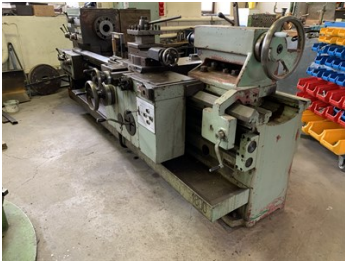
- * 1. Installed lathe required a solid foundation ,
- * 2. Temporary wood dam prepared ,
- * 3. Pouring Belzona 7111 ,
- * 4. Final Application ,

Installed lathe at a machine building manufacturer which required a solid foundation.
