# Belzona 1593 special internal coating

Industry: Oil & Gas  
Application: HEX-Heat Exchangers  
Substrate: Steel  
Products: \* Belzona 1593 ,

Customer Location: Bratislava, Slovakia  
Application Date: 2020

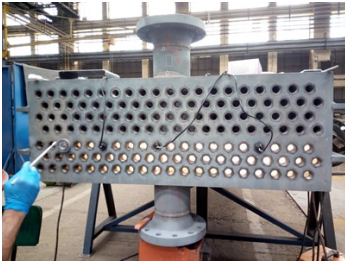
*Chemical attack (corrosion) was only one problem, another problem was that coating area was not easy available.*

- \* 1. Customer needed to protect internal tube sheet ,
- \* 2. We needed to use special tools for blasting ,
- \* 3. Tube sheet was coated with product Belzona 1593 ,
- \* 4. Ready to work ,

Customer needed to protect internal tube sheet of the air condenser. We have offered him product Belzona 1593, which could be used for hydrocarbons in 150°C.
