# Belzona 5721 - Leading edge protection for cold weather blades

ID: 8398

Customer Location: Wind Farm, Norway  
Application Date: 2020

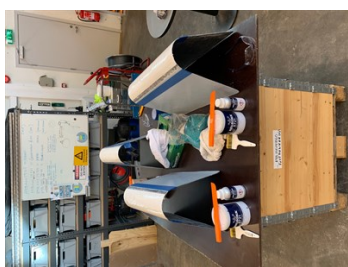
- \* 1. Product Training - Kit ,
- \* 2. Surface Preparation ,
- \* 3. Application in Progress ,
- \* 4. Norwegian Wind farm ,
