Belzona 5721 - Leading edge protection for cold weather blades

ID: 8398

Customer Location: Wind Farm, Norway
Application Date: 2020

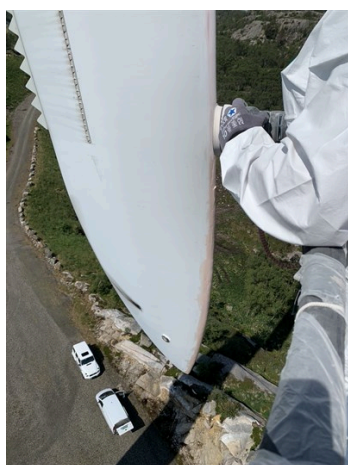
- * 1. Product Training - Kit ,
- * 2. Surface Preparation ,
- * 3. Application in Progress ,
- * 4. Norwegian Wind farm ,

The application was carried out in accordance with a modified version of Belzona Know-How System Leaflet FBC-1. The blades were coated on the turbine at the operation site. The pitting and loss of surface on the leading edge was resurfaced with a filler product and rebuilt to dimensions. The surface area was sanded down with a mechanical sander and cleaned with a rag and non-residual solvent cleaner. One coat of Belzona 5721 at 20 mils (508µm) was applied.
