# PINTLE REPAIR WITH BELZONA

ID: 840

Pintle housing on cargo ship.

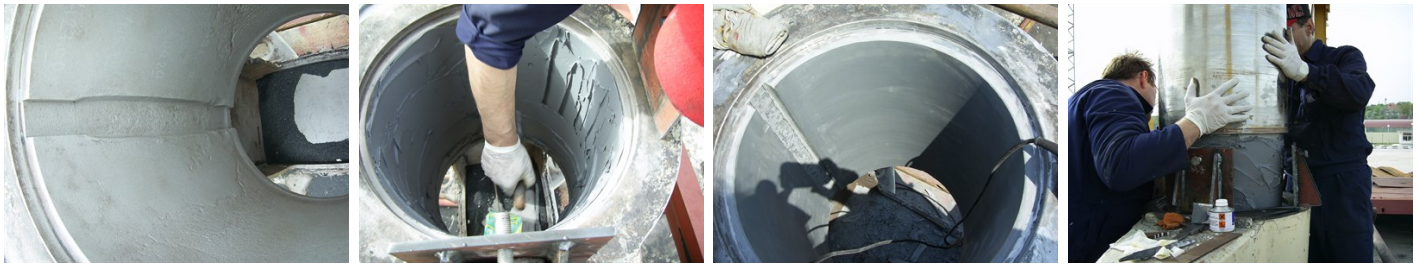
## Photograph Descriptions

*The keyway was damaged by galvanic corrosion and in certain areas the damage reached 40mm in width. Corrosion pitting was severe, up to 12 mm deep in the tapered housing.*

- \* Prepared Surface ,
- \* Application of Belzona to housing ,
- \* Rebuilt keyway and housing surfaces ,
- \* Fitting the Pintle ,

Application was carried out in accordance with Belzona Know-How System Leaflet SOS-3. The keyway channel on the rudder was infilled and a new channel machined at 180°.

Boring was not an option because the diameter was so far gone. Customer had to rebuild up to 2 cm of metal on the taper of the rudder in order to get correct fit. Belzona was more cost effective and faster than traditional methods such as welding and provided galvanic corrosion protection by isolating the dissimilar metals.
