Belzona Restores Concrete Settlement Tank Walls

ID: 8411

Industry: Water / Wastewater
Application: TCC-Tanks and Chemical Containment Areas

Customer Location: Lancashire, UK
Application Date: October 2020

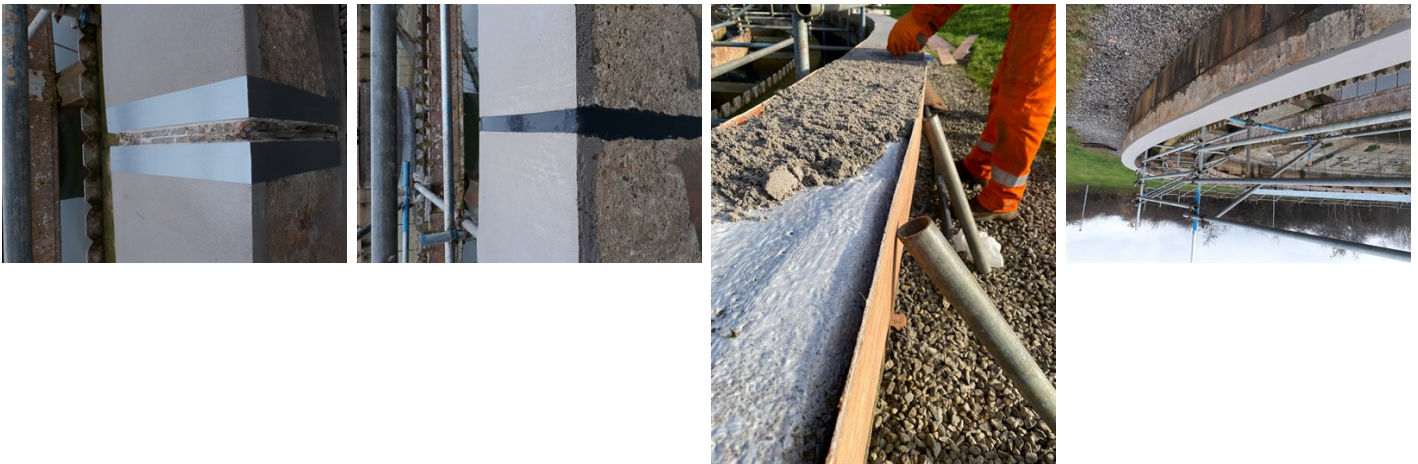
Photograph Descriptions

Problem

The top of the concrete walls of multiple FST's had suffered from abrasive wear due to the action of the wheels that drive the rotating separator arms. This has been further aggravated by freeze-thaw cycles on the damaged and damp concrete substrate. There has also been damage to expansion joints, which have been repaired previously, but began showing signs of failure.

- * 1 - Expansion joint before repair ,
- * 2 - Expansion joint after repair ,
- * 3 - Belzona 4131 during application ,
- * 4 - Repair completed ,

Belzona 4131 was applied to the top of the walls to create a hard, compression and abrasion resistant surface to provide long term protection and prolong its service life. The expansion joints were removed and replaced with Belzona 2211 to allow for the

expansion/contraction of the concrete. The work was completed in accordance with Belzona System Leaflets TCC-09, TCC-11 & TCC-12.

Belzona 4131 provided better abrasion protection than the original concrete substrate, and Belzona 2211 gives flexibility and very high adhesion to the surrounding material.
