# Belzona Superwrap II Application inside Marine Sewage Tank

ID: 8414

Customer Location: Scotland  
Application Date: July 2020

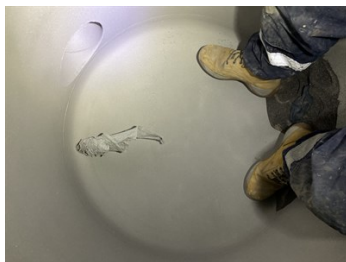
- \* 1 - The areas of metal loss are marked in red here ,
- \* 2 - Surface preparation, the tight access is apparent. Aluminium Oxide grit was used to achieve the required surface profile on stainless steel. ,
- \* 3 - Belzona Superwrap system applied to walls & tank base. The ability to encapsulation complex geometry is shown here ,
- \* 4 - Belzona 5811 applied ,

A stainless steel marine sewage tank was experiencing extensive metal loss through pitting corrosion. The welds within the tank were being badly affected & the customer was concerned the tank would soon begin to leak.
