Pharmaceutical Plant uses Belzona Safety Grip System

ID: 8418

Customer Location: Switzerland
Application Date: May 2020

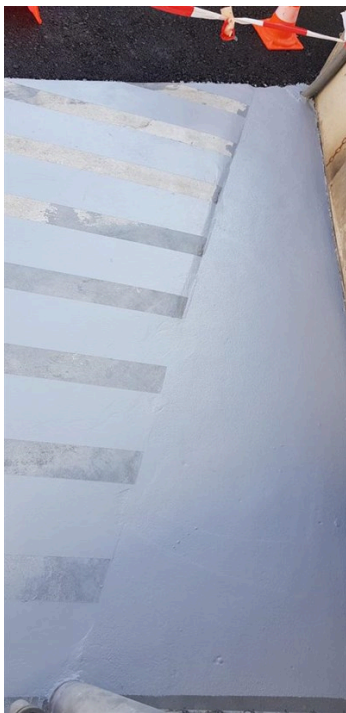
The exterior flooring was an issue when the Pharmaceutical Plant forklift trucks were operating outside, causing the forklifts to slip when loading and un-loading.

- * Image 1: Application of Belzona 5231 ,
- * Image 2: Strips of Belzona 5231 ,
- * Image 3: Close up ,
- * Image 4: Final Application Complete ,

Areas of concrete were repaired with Belzona 4111. The Belzona 5231 was then applied in accordance with System leaflet FPA-8 to the concrete and then the Belzona 1821 and Belzona 9211 grip system was used to create a safety grip system then overcoated with Belzona 5233 for increased UV Stability.
