Belzona Solves Tank Base Sealing Problems

Customer Location: Oil Terminal, Scotland

Application Date: October 2020

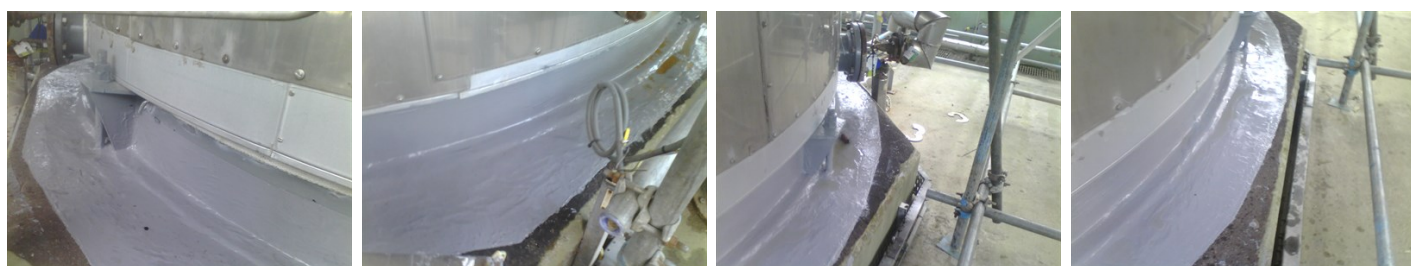
Photograph Descriptions

* 1,2,3,4 - finished image of Belzona system around annular rim ,

The application was carried out in accordance with Belzona System Leaflet GSS-03. The base of the tank was grit blasted, Belzona 6111 was then applied to provide corrosion protection. Bridging tape & Belzona 3921 were applied & then Belzona 3111 as a two coat system.

The flexible microporous system effectively sealed the tank annular rim from any external water penetration.
