# Belzona Keeps Fishing for 20 years.

ID: 8427

Application: FPA-Floor Problem Areas

Customer Location: Perth, Western Australia

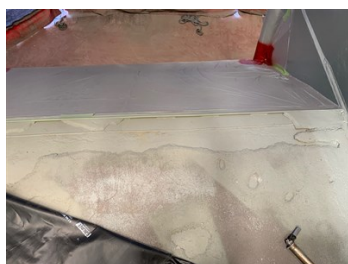
- \* 1. Fishing Trawlers ,
- \* 2. Stern ramp deck prior to repair ,
- \* 3. Close up of original 20 year old Belzona 4000 product ,
- \* 4. New repairs complete. ,
