# Belzona Keeps Fishing for 20 years.

ID: 8427

Industry: *Marine*  
 Application: *FPA-Floor Problem Areas*  
 Substrate: *Steel*  
 Products: *\* Belzona 4911 (Magma TX conditioner),*  
*\* Belzona 4111 (Magma Quartz),*

Customer Location: *Perth, Western Australia*Application Date: *2000 and 2020*

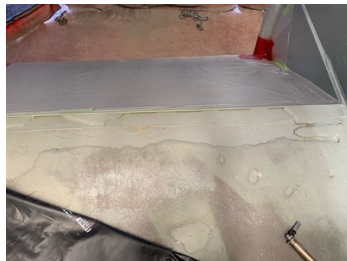
- \* 1. Fishing Trawlers ,
- \* 2. Stern ramp deck prior to repair ,
- \* 3. Close up of original 20 year old Belzona 4000 product ,
- \* 4. New repairs complete. ,

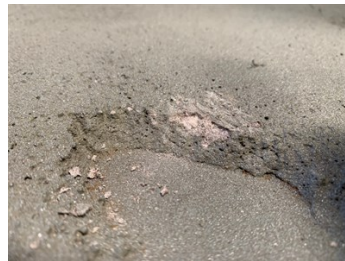
Now in 2020, some 20 years after the original application, some localized areas required attention and re-laying of Belzona 4111.

The localized areas were mechanically abraded and the Belzona 4111 was troweled into the areas to be patched.

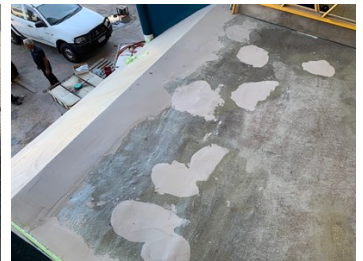
The same engineer applied both Belzona products some 20 years apart - it was very evident that the original Belzona was extremely durable and robust making the decision to carry out the patch repairs with Belzona a very easy one.
