Belzona Protects Screw Conveyor Against Abrasive Attack

ID: 8433

Industry: Power
Application: SHM-Solids Handling Machinery

Customer Location: Biomass Plant, Glasgow, UK
Application Date: November 2019

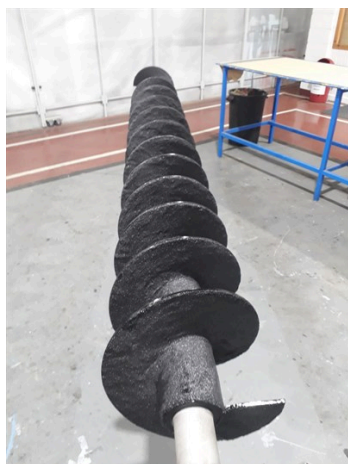
High abrasion was leading to unprotected screws only lasting 3-4 months in service. Previous Belzona applications on this type of screw was completed with Belzona 1812, which extended their life to over 2 years.

Screw conveyor used to skim sludge from the base of a silo at a biomass plant.

The application was completed in accordance with system leaflet SHM-14. The screw conveyor was grit blasted to SA2 1/2 with a minimum surface profile of 3 mil (75 microns). The area to be coated was then cleaned and degreased using Belzona 9111. Belzona 1814 was applied by brush to the entire area of the conveyor to provide long-term protection against heavy abrasion.
