# Brewery Sugar Store Drain Repaired with Belzona

Application: FPA-Floor Problem Areas

Customer Location: Burton-on-Trent, UK

Application Date: October 2020

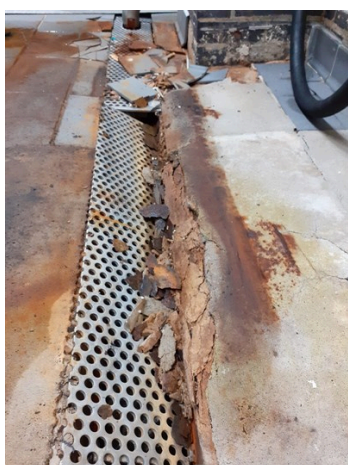
\* 1. Completed works awaiting curing, prior to refitting drain covers 2. New shoulders and downpipe formed 3. New downpipe and central section formed ,

On removal of all the superficial damaged substrate it was noted that there was far more excavation to be done than first thought. All the wet material was removed back to a solid surface. The drain downpipe had collapsed and the distributors engineers fitted a new one made up from standard parts from a builder's yard, adapting, cutting and fitting it to suit. The drain profile was formed by hand from Belzona 4131, installing plastic sections, again made for the actual installation from other parts, and the new shoulders for the drain were formed. On removal of all the formers, the drain was back to the size and standard required, leaving the customer extremely happy.
