Weatherproofing Electrical Zipper Boots The Belzona Way

ID: 8440

Industry: Power
Application: RPA-Roof Problem Areas
Substrate: Rubber
Products: * Belzona 3121 (MR7) ,
* Belzona 1121 (Super XL-Metal) ,
* Belzona 9341 (Reinforcement sheet) ,

Customer Location: Decatur, AL
Application Date: November 2020

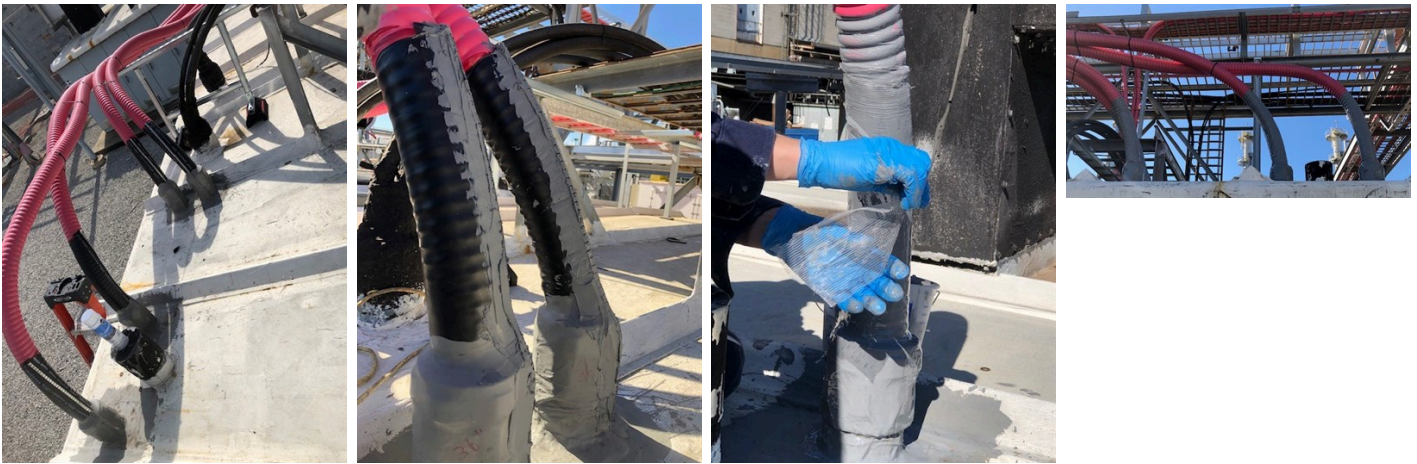
Weather deteriorated the original zipper boot causing water penetration inside the panel leading to power failure.

- * 1. Unprotected electrical zipper boots ,
- * 2. Applied Belzona 1121 ,
- * 3. Applying Belzona 9341 and Belzona 3121 ,
- * 4. Finished weatherproofed electrical boot ,

After removing any loose debris we then cleaned each boot with 9111. We then applied the 1121 to each side of the zipper to create a more uniform surface area. Once the 1121 cured we then applied a coat of 3121 to the zipper boot. The applying the 9341 wrap at a minimum of thirty-six inches in height. Once the wrap was completed we then added the final coat of 3121 over the wrap completing the job.
