Belzona used for the protection of a wind turbine blade

ID: 8441

Problem

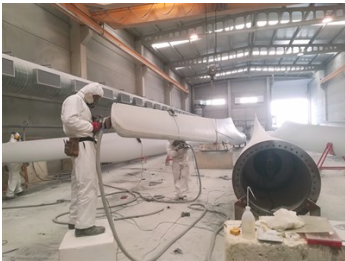
- * 1. Surface preparation ,
- * 2. Application of Belzona 5721 ,
- * 3. First layer complete ,
- * 4. Final layer complete ,

The leading edge of the blade has been prepared using hand held sander power tool, removing the existing gel-coat and to provide a clean and rough surface. After cleaning the prepared area, the Belzona 5721 system has been applied as a one-coat system at an average of 500 microns.
