# Belzona Helps Protect Offshore Platform Legs At A Waterline

Industry: Oil & Gas  
Application: SOS-Ships and Offshore Structures

Customer Location: Baltic Sea  
Application Date: September 2020

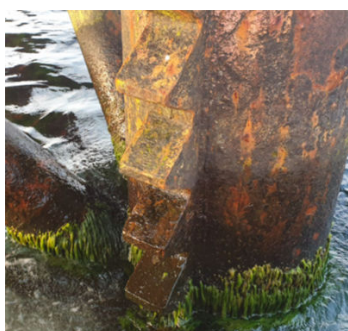
Corrosion of platform legs in the splash zones.

- \* 1. Corroded platform legs ,
- \* 2. Surface preparation ,
- \* 3. Belzona 5831 in use. ,
- \* 4. Platform ,

Original corrosion protection damaged on platform legs.

Application was carried out using a modified version of Belzona Know-How System Leaflet SOS-21. After wet abrasive blasting the Belzona 5831 was applied to the corroded areas above the waterline.
