Belzona Repairs Leaking Gate Valve

ID: 8450

Industry: Oil & Gas
 Application: VPF-Valves, Pipes and Fittings
 Substrate: Mild steel
 Products: * Belzona 1212 ,

Customer Location: Oil Terminal, Scotland
 Application Date: October 2019

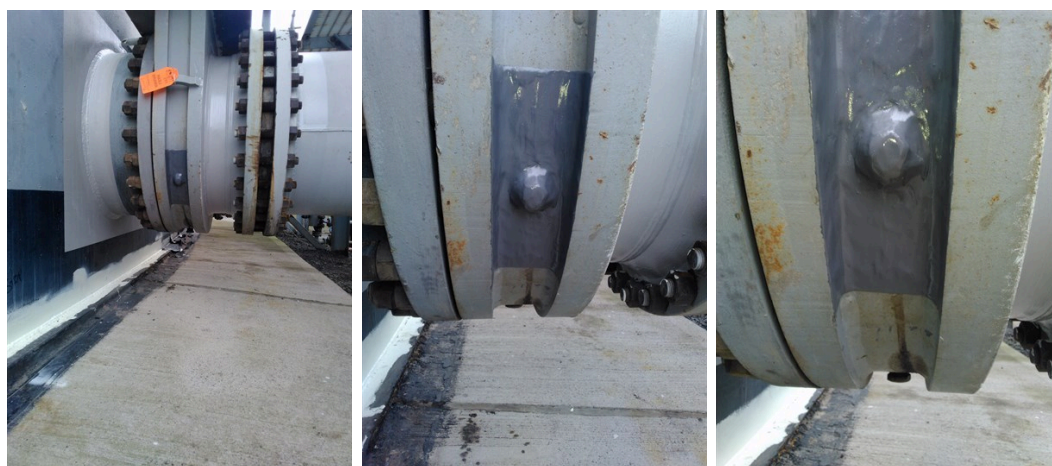
Hot works in the area were not possible due to the asset remaining in service. The plug was no longer effective, and the leak required sealing.

- * 1 - Gate Valve ,
- * 2 - Close up of repair area ,
- * 3 - Close up of repair area (2) ,

A large diameter valve had a redundant plug that was leaking fluid. A cold solution was required to seal this leak.

The area was prepared mechanically. Belzona 1212 was then applied to the surface to prevent any further fluid egress and encapsulate the plug in accordance with Belzona System Leaflet VPF-11.

It was possible to carry out these works cold. Hot works would have been more hazardous & had the possibility of distorting the gate valve.

Due to restrictions on photography onsite, an updated picture is not possible. However, the application has been reviewed three years later and the repair is still in good condition and preventing leaks.
