Belzona takes the heat off

ID: 8453

Industry: Steel & Metal Processing
Application: VPF-Valves, Pipes and Fittings
Substrate: Carbon Steel
Products: * Belzona 5871 ,

Customer Location: Huelva, Spain
Application Date: November 2020

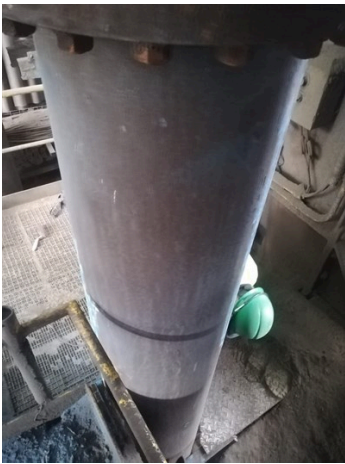
Due to the contamination and dirt found in the environment close to the pipeline, the insulation material had degraded and was no longer fit for purpose. Unfortunately, this left the hot surface of the pipeline exposed, causing a hazard to personnel working in the area. The pipeline operated at between 80C and 100C. The surface must be below 60C to be considered safe.

- * 1. Pipe prior to application ,
- * 2. Surface preparation completed ,
- * 3. Application completed ,
- * 4. Surface temperature after curing ,

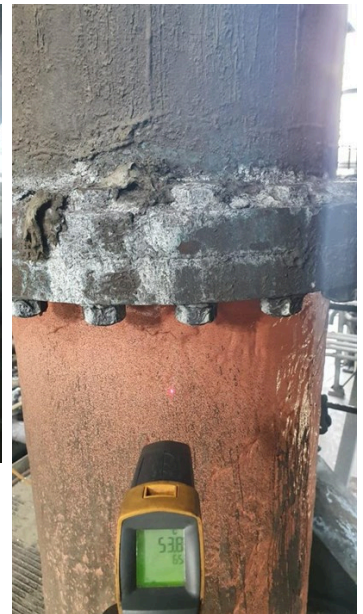
The key factor in this situation was to minimise the downtime of the equipment. Due to the single layer application of the Belzona 5871, the application was carried out, and sufficient curing time achieved, within a 6 hour downtime window. Alternative solutions included reinstatement of traditional insulation, which would have taken much longer to install, therefore increasing the downtime. The final surface temperature after the Belzona 5871 was fully cured was below the 60C limit, making it safe for personnel to work in the area.
