# Belzona repairs and protects separator outlet in paper mill

ID: 8466

Application: *SHM-Solids Handling Machinery*

Basalt lined outlet area of a separator in a paper mill.

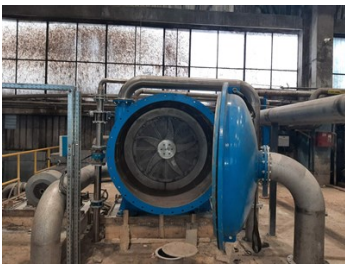
- \* 1. View of the Separator ,
- \* 2. Cracked outlet pipe ,
- \* 3. Crack repaired with Belzona 1111 ,
- \* 4. Application completed with Belzona 1811 ,

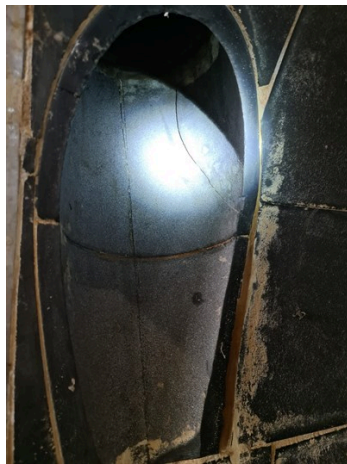
*The Basalt lining was worn due to the erosive operating conditions of the separator. In the outlet pipe, a crack had formed due to the high impact loading in this area.*

The cracked area has warped, leaving one side of the crack raised above the other, which in turn accelerated the abrasive wear. Traditional solutions such as welding would only fill the gap and not allow for a smooth finish to help reduce the abrasive wear. Belzona was able to reinforce the cracked area and smooth the internal section of the pipe. Belzona 1811 was chosen due to its high abrasion resistant properties and ease of application in situ. The application was completed within 2 days, keeping down time to a minimum.

cracked area was then repaired using Belzona 1111 to bond a reinforcement plate over the defect area, inline with Belzona System Leaflet TCC-2. Belzona 1811 was then applied to the outlet pipe and to some worn areas of the Basalt lining inline with Belzona System Leaflet SHM-11, offering additional erosion and abrasion protection.
