# Wastewater repair and protection with Belzona

ID: 8468

Application: VPF-Valves, Pipes and Fittings

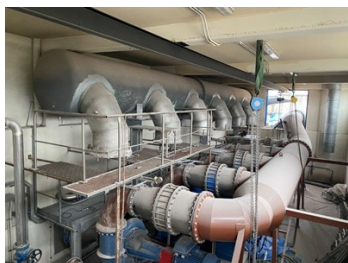
- \* 1 - Outside of the pipes to be repaired ,
- \* 2 - Corroded condition inside the pipe ,
- \* 3 - Surface prepared and rebuilding in progress ,
- \* 4 - Coating completed ,

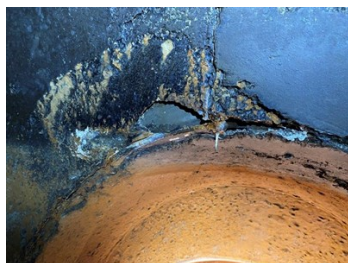
*Internal corrosion of the pipelines has lead to severe degradation of the substrate including heavy pitting. In some areas, the loss of wall thickness is reaching a stage where the structural integrity of the pipeline would be compromised. Action is needed to repair the existing damage and prevent further corrosion.*
