Wastewater repair and protection with Belzona

Application: VPF-Valves, Pipes and Fittings

Sewage water pipelines at a waste water treatment facility.

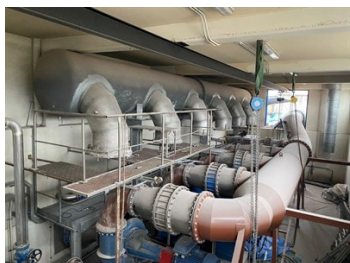
- * 1 - Outside of the pipes to be repaired ,
- * 2 - Corroded condition inside the pipe ,
- * 3 - Surface prepared and rebuilding in progress ,
- * 4 - Coating completed ,
