BELZONA PROTECTION OF INTERNAL & EXTERNAL SURFACES OF LIFT PUMP

ID: 847

Customer Location: Oil Company, Saudi Arabia
Application Date: April 2007

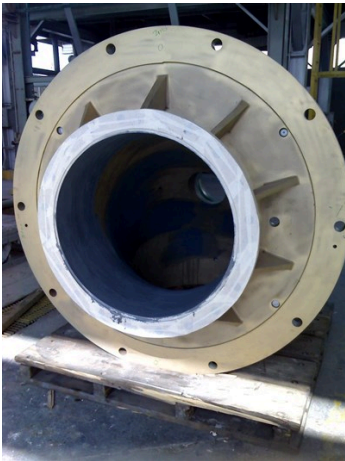
This High Lift Pump for the Refinery was suffering erosion and corrosion on all surfaces.

- * Rebuilding the pump head ,
- * Spools after blasting ,
- * External coating for spools ,
- * Completed application ,

The application was carried out in accordance with Belzona Know-How System Leaflets CEP-3 and CEP-5.
