# Belzona restores structural integrity and stops leak.

Customer Location: Binary cycle power plant, Central north island, New Zealand.

Application: VPF-Valves, Pipes and Fittings

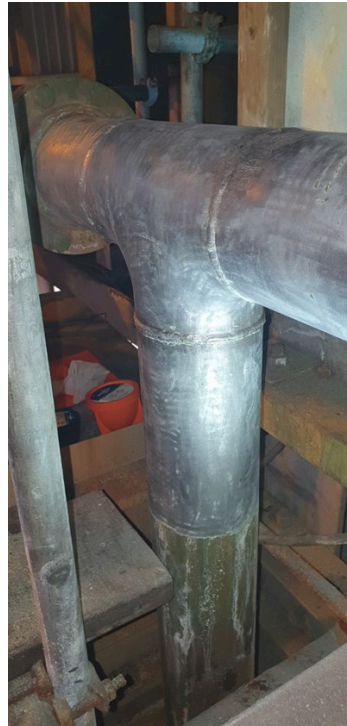
Corrosion and thinning of the pipeline had failed on most welds. There was an area on a T-junction where the line was leaking extensively. Due to the awkward positioning of the pipe, welding was not possible.

- \* 1. Badly damaged T-section of the pipe ,
- \* 2. Manually prepped surface ,
- \* 3. Application of Belzona Superwrap II ,
- \* 4. Final output ,

The application was carried out as per the Belzona System Leaflet VP11 and Belzona Superwrap II method statement provided. In order for the products to adhere successfully to the substrate, we had requested the organization to divert the water supply from the pipeline. Once this was achieved, We had to manually prep the substrate. Belzona 1161 was used to rebuild the profile and stop the leak. After consulting the IFU for 1161, Belzona 1982 was used. The Belzona SuperWrap II release film was then wrapped over the repair and the left to cure.
