Belzona Backhoe Bush Housing Repair

ID: 8472

Backhoe Bush Housings

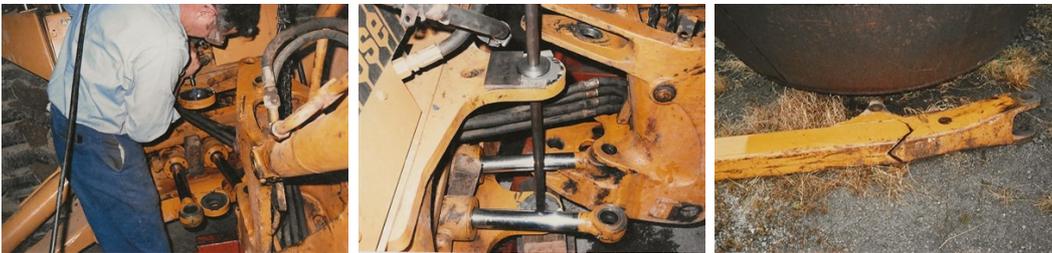
Photograph Descriptions

The bush housings, where the boom attaches to the machine, were worn till they were oversized that it was difficult to properly control the boom when digging. Also, it was the busy construction season and the owner needed the machine back as soon as possible. The machine shop where it was taken for repair suggested they try a procedure using Belzona 1111, which had recently been introduced to the machine shop owner.

- * 1. Preparation of the worn housings by grinding ,
- * 2. New bushings grouted in and alignment rod in place ,
- * 3. The cracked boom which resulted from hitting an underpass ,

Application was carried out in accordance with Belzona Know-How System Leaflet MPT-07. The worn housings were degreased, ground to produce a rough profile and degreased again. Release Agent was applied to the OD of new bushings and allowed to dry. Belzona 1111 was mixed and applied to both the prepared housings and onto the new bushings, on top of the release agent. The bushings were inserted into the housings and a steel rod, exactly the size of the bushing ID, was run through both bushings to provide alignment. The repair was allowed to cure overnight. Next morning the machine was reassembled, the owner picked it up and it was digging later that day.

The owner was delighted that the backhoe was only out of service one day, as opposed to two or more for welding and line-boring, as this shop had done for him in the past. The cost of the Belzona repair was a fraction of the welding approach and the machine required minimal disassembly. This repair was followed for over 5 years with no problems. During that time, the boom was cracked when it hit a low underpass while the machine was being transported. The Belzona 1111 repair remained intact. (see photo #3)
