Belzona Repair And Protect Offshore Closed Drain Tank

ID: 8475

Customer Location: North Sea Norway
Application Date: April 2019

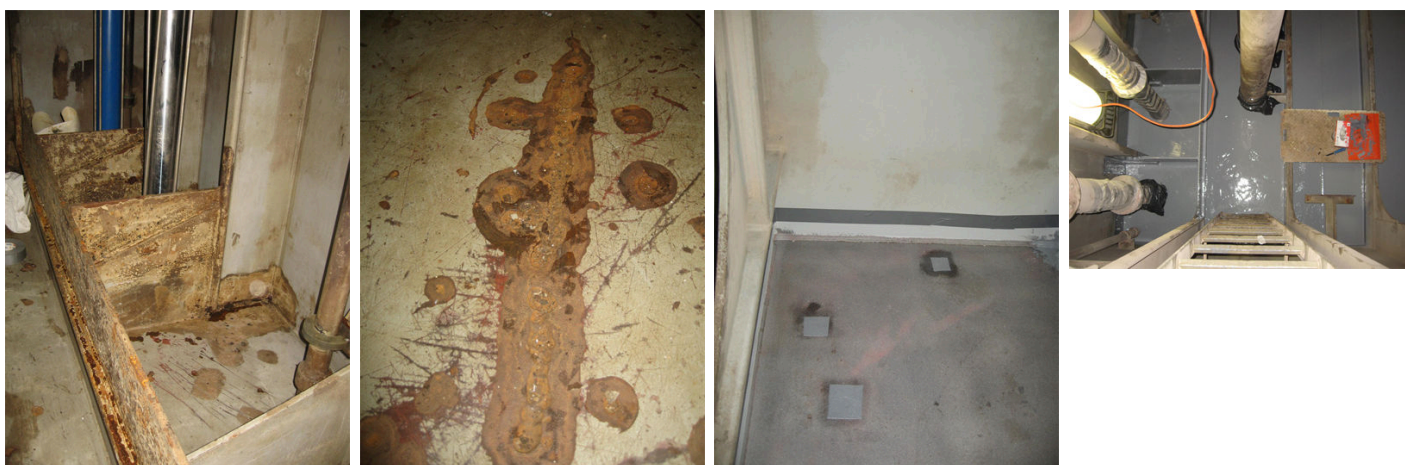
Photograph Descriptions

Severe pitting corrosion in bottom section of internal closed drain tank, due to coating failure. Metal loss in areas measured to 6-8mm deep.

- * Picture 1. Corroded tank bottom ,
- * Picture 2. Severe pitting corrosion ,
- * Picture 3. gritblasted surfaces and rebuilding of pitted areas using Belzona 1111 Supermetal ,
- * Picture 4. Tank bottom coated with belzona 5811 Immersion grade. ,

Application was carried out in accordance with Belzona Know-How System Leaflet TCC-5. Following gritblasting, Belzona 1111 Supermetal was used to fill all pitted areas in the tank bottom. All tank bottom surfaces were then coated in Belzona 5811 Immersion Grade.
