Belzona® Repairs Robotic Arm

ID: 8477

Industry: Food & Drink
Application: VPF-Valves, Pipes and Fittings
Substrate: Hard Aluminium
Products: * Belzona 1111 (SuperMetal) ,
* Belzona 9341 ,

Customer Location: Brewery, Romania
Application Date: February, 2021

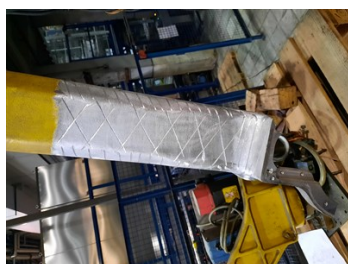
The robotic arm, that lifts and moves around large plastic beer boxes, from stack to process lines, was totally broken due to the metal wear. It had been working continuously for the last 20 years.

- * 1. The view of the broken robotic arm ,
- * 2. The view of the surface prepared by using the MBX ,
- * 3. The two pieces of the arm with the wrapping of the reinforcement sheet ,
- * 4. The robotic arm with the completed repair .

After proper surface preparation, the application was carried out by putting the metal plates with screws on the broken arm. Belzona 1111 was applied between the two pieces of metal right on the tear of the pieces. After bonding the two pieces of the arm, the reinforcement sheet (Belzona 9341) was wrapped around the entire damaged area, which was wet out with Belzona 1111.
