Turbo Separator Repair With Belzona 1818

ID: 8480

Industry: Pulp & Paper
Application: SHM-Solids Handling Machinery

Turbo separator in Paper recycling plant

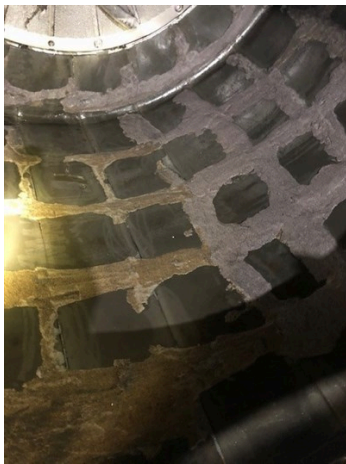
The Turbo Separator is a disc screen specially designed for coarse screening, primarily removing light and heavy impurities from wastepaper. The unit is lined with thick Basalt tiles and has a hard-wearing grouting compound applied over the joints between the tiles. Over the years, this grouting compound would wear away leaving the joints unprotected. This is a very abrasive environment.

Worn grouting system

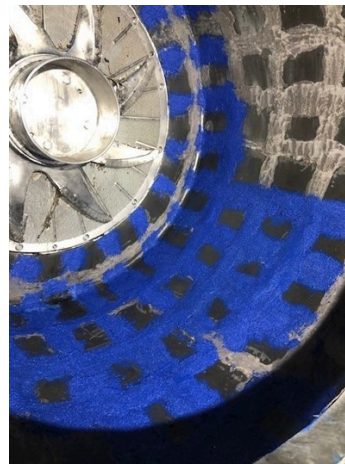
Application in progress

Belzona 1818 was mixed and applied with ease, including overhead areas.

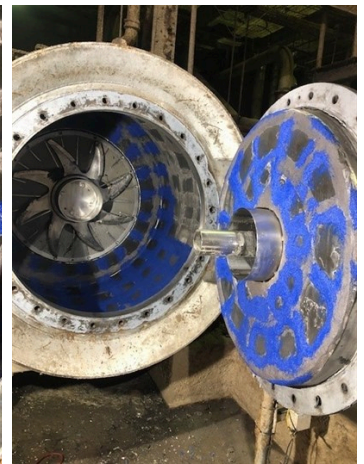
Application complete
