Big Vacuum Oven Repair With Belzona 1593

ID: 8481

Industry: Chemical & Petrochemical
Application: TCC-Tanks and Chemical Containment Areas
Substrate: Steel
Products: * Belzona 1593 ,
* Belzona 9111 (Cleaner Degreaser) ,

Customer Location: Slovakia
Application Date: 2019

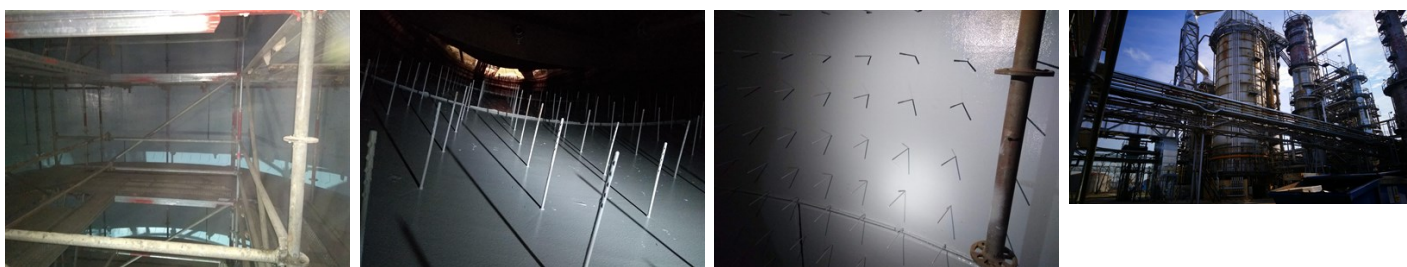
- * 1. It was necessary to erect up scaffolding. ,
- * 2. Steel prickles were coated too. ,
- * 3. 2nd coat of Belzona 1593 applied. ,
- * 4. Oven ready to use. ,

The application was performed in accordance with Belzona system leaflet TCC-5. After blasting and cleaning, the oven was applied with Belzona 1593 in 2 layers. The first coat of Belzona 1593 was applied at 375 microns. After 12 hours the second coat was applied at 375 microns. Complete coating was finished in 2 days.
