Belzona protects new seawater filters for desalination

ID: 8484

As part of the construction of a new Reverse Osmosis Desalination plant, 14 large media filters have been manufactured and are in need of internal protection.

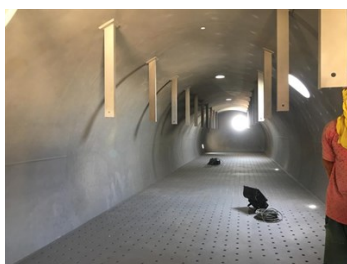
- * 1. View of the filters from the outside ,
- * 2. Internal surface after surface preparation ,
- * 3. Internal surface after first coat ,
- * 4. Completed application ,

The coating was applied in accordance with a modified version of Belzona System Leaflet TCC-5, and in accordance with the Belzona 5821 IFU. The substrate was prepared using grit blasting to achieve the required surface cleanliness and profile. A two coat system of Belzona 5821 was then applied by airless spray.
