Belzona protects Wastewater expansion bellows.

ID: 8488

Industry: Water / Wastewater
Application: SHM-Solids Handling Machinery

Customer Location: Washington
Application Date: April 2021

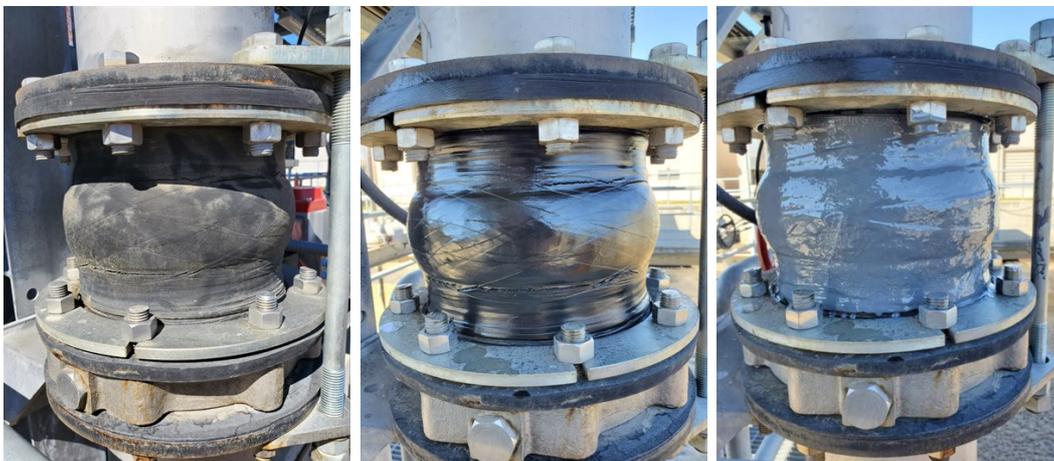
Photograph Descriptions

These rubber wastewater expansion bellows were being weathered by UV and exposure resulting in cracking.

- * 1. Original condition. ,
- * 2. Belzona 2911 applied. ,
- * 3. Belzona 2221 and 9341 applied, application complete. ,

Surface prep was done with coarse emery cloth and blown clean. Belzona 2911 was applied and allowed to dry as per the IFU. Belzona 2221 was mixed and the cracks filled and the entire surface wetted out with a brush. Then the Belzona 9341 was wrapped around the bellows and pulled tight until the 2221 squeezed through the reinforcement tape and the remaining 2221 was applied by brush to overcoat and seal in the reinforcement tape.
