Belzona 1212 for Emergency pump repair

Industry: *Water / Wastewater*
Application: *PDP-Positive Displacement Pumps*

Wastewater lift station pump

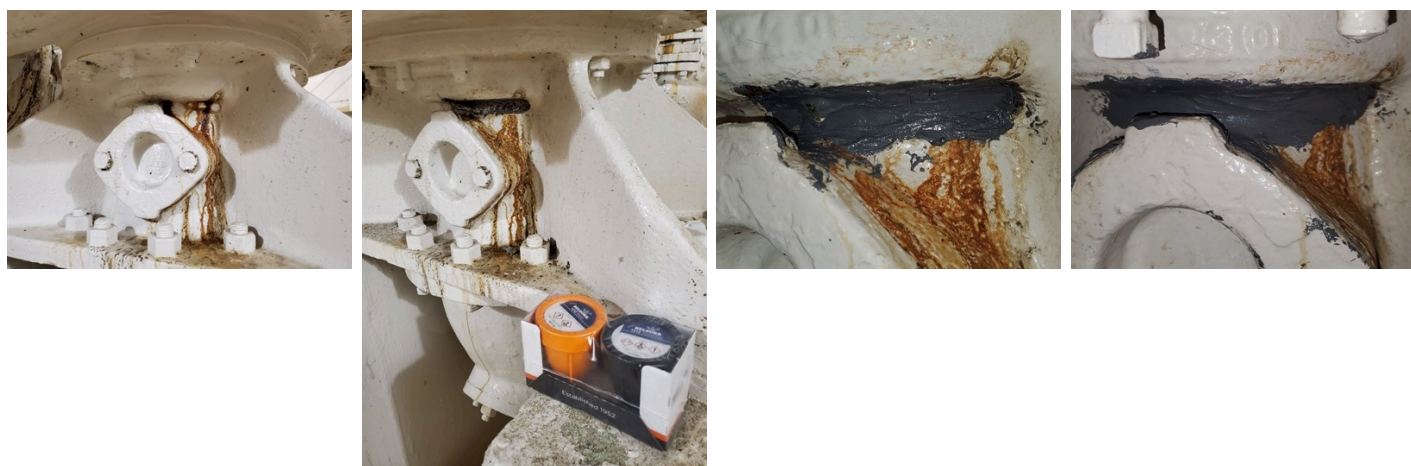
A faulty section of weld on the lower side of the pump was leaking raw sewage.

- * 1. Original condition of the pump. ,
- * 2. Paint removed and ready for the 1212. ,
- * 3. First application of 1212 with a small drop of water on the left side. ,
- * 4. Second application of 1212 and leak sealed. ,

The location of the faulty weld was tight and difficult to reach, but a dremel tool was able to just reach in and remove the paint and corrosion and roughen the surface. During the application the pump was not running, but there was still a small amount of water pressure causing a slow seeping drip. Belzona 1212 was mixed according to the IFU and allowed to sit on the mixing board until only 45 seconds of working life was remaining. Then the 1212 was quickly applied over the active seep and pushed into place by hand. This slowed the seep considerably, and one final batch of 1212 was mixed and applied in the same manner which stopped the leak completely.

The cost to replace this pump would be in the \$20,000.00 range, and to remove the pump to reweld the area would probably cost around \$5,000.00. The Belzona solution of using Belzona 1212 allowed for a repair using a small amount of material, and an hour of time, and was carried out while the pump was in its usual rotation of not being used.
