Belzona 1212 for Emergency pump repair

ID: 8489

Industry: Water / Wastewater
Application: PDP-Positive Displacement Pumps

Wastewater lift station pump

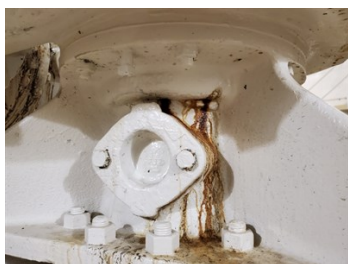
A faulty section of weld on the lower side of the pump was leaking raw sewage.

- * 1. Original condition of the pump . ,
- * 2. Paint removed and ready for the 1212. ,
- * 3. First application of 1212 with a small drop of water on the left side. ,
- * 4. Second application of 1212 and leak sealed. ,
