BELZONA COATED CHILLERS 10 YEARS ON

Industry: General Industry
Application: HEX-Heat Exchangers
Substrate: Cast Iron
Products: Belzona® 1321 (Ceramic S-Metal)

Customer Location: Olympic Stadium: Montréal, Canada
Application Date: 1996

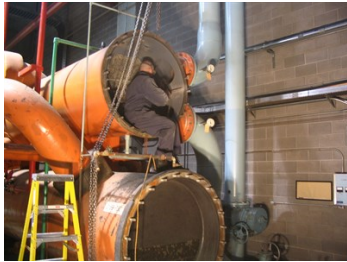
Photograph Descriptions

* The chiller units , * The covers required minor touch-up , * The separator bar after 10 years , * The separator good for another 10 years ,

Application was done according to Belzona System leaflet HEX-1. After 10 years, Separator was sandblasted and entirely re-coated. Small touch ups were needed on covers and separator slides. The gap on separator was opened up with sandblast to solve this problem and sliding was made easier.
