# BELZONA COATED CHILLERS 10 YEARS ON

ID: 849

Industry: General Industry  
Application: HEX-Heat Exchangers  
Substrate: Cast Iron  
Products: Belzona® 1321 (Ceramic S-Metal)

Customer Location: Olympic Stadium: Montréal, Canada  
Application Date: 1996

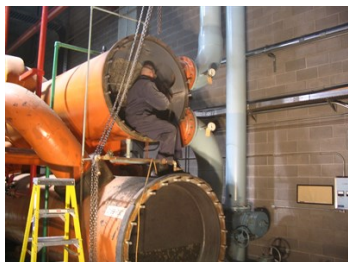
\* The chiller units , \* The covers required minor touch-up , \* The separator bar after 10 years , \* The separator good for another 10 years ,

Application was done according to Belzona System leaflet HEX-1. After 10 years, Separator was sandblasted and entirely re-coated. Small touch ups were needed on covers and separator slides. The gap on separator was opened up with sandblast to solve this problem and sliding was made easier.
