# BELZONA COATED CHILLERS 10 YEARS ON

Industry: *General Industry*  
Application: *HEX-Heat Exchangers*  
Substrate: *Cast Iron*  
Products: *Belzona® 1321 (Ceramic S-Metal)*

Customer Location: *Olympic Stadium: Montréal, Canada*  
Application Date: *1996*

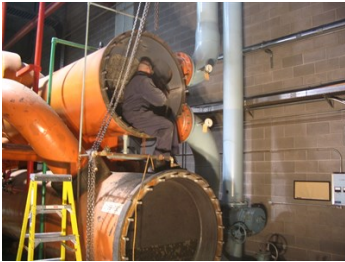
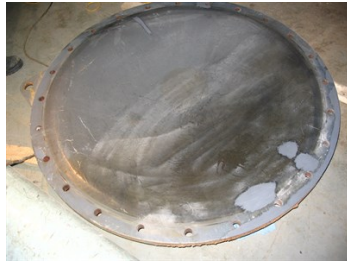
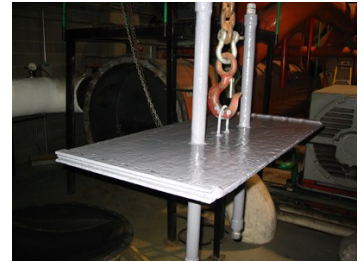
\* The chiller units , \* The covers required minor touch-up , \* The separator bar after 10 years , \* The separator good for another 10 years ,

Application was done according to Belzona System leaflet HEX-1. After 10 years, Separator was sandblasted and entirely re-coated. Small touch ups were needed on covers and separator slides. The gap on separator was opened up with sandblast to solve this problem and sliding was made easier.
