DAMAGED LOADING BAY STAYS STRONG WITH BELZONA

Customer Location: Industrial gas supplier, UK

Application: FPA-Floor Problem Areas

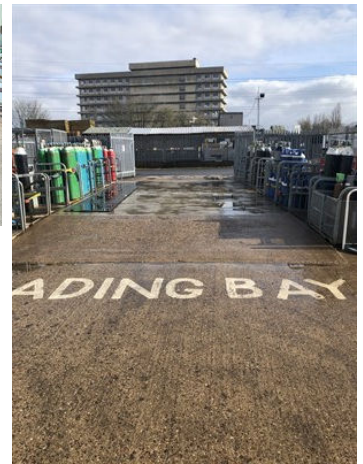
The surface of the concrete ramp had become damaged due to impact from the gas cylinders when being loaded and unloaded, even though they are dropped onto a rubber mat. The uneven surface was making it increasingly difficult for the tall narrow cylinders to stand up safely.

- * 1. 8.5m x 5m concrete loading area damaged by impact ,
- * 2. Extent of the damage ,
- * 3. Repaired with 6mm of Belzona 4131 ,
- * 4. Application revisited in 2021 after 9 years in service ,

The application was completed in accordance with Belzona Know-How System Leaflet FPA-1. The concrete ramp was pressure washed to remove surface contamination before the Belzona 4131 system was applied to the ramp.

This is a common problem on many gas distribution sites across the UK. Belzona was selected firstly for its ability to protect against impact and abrasion. Secondly for being impermeable and resistant to frost damage. After nine years of constant loading and unloading of gas cylinders the loading bay has been revisited in May 2021 and was found to be in excellent condition. The client is very impressed with the Belzona solution provided and has since implemented a variety other successful Belzona applications across their UK sites.
