# DAMAGED LOADING BAY STAYS STRONG WITH BELZONA

ID: 8495

Customer Location: Industrial gas supplier, UK  
 Application Date: March 2012

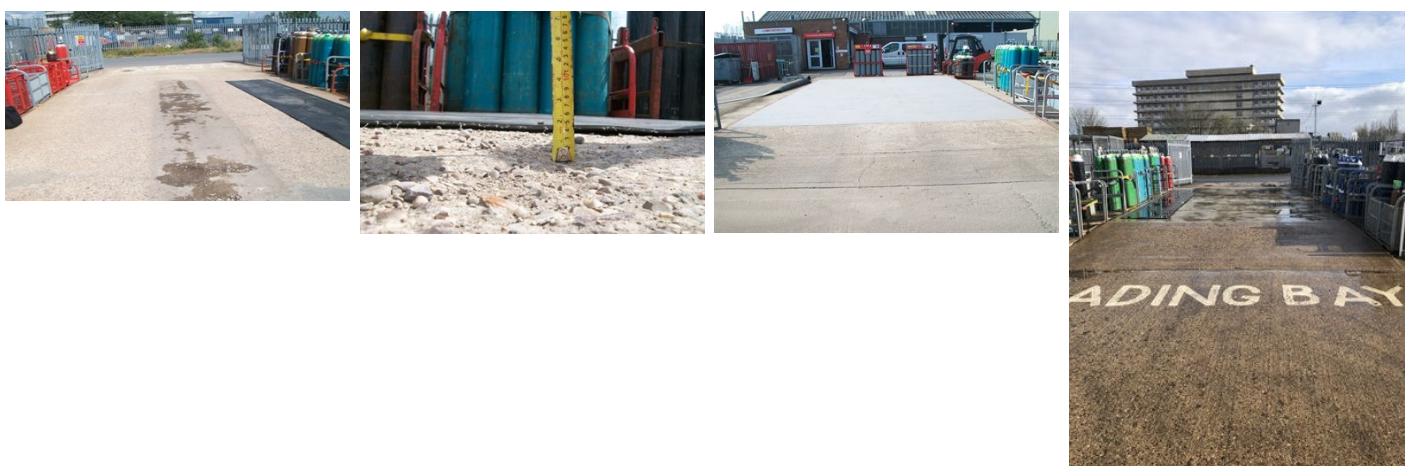
## Photograph Descriptions

The surface of the concrete ramp had become damaged due to impact from the gas cylinders when being loaded and unloaded, even though they are dropped onto a rubber mat. The uneven surface was making it increasingly difficult for the tall narrow cylinders to stand up safely.

- \* 1. 8.5m x 5m concrete loading area damaged by impact ,
- \* 2. Extent of the damage ,
- \* 3. Repaired with 6mm of Belzona 4131 ,
- \* 4. Application revisited in 2021 after 9 years in service ,

The application was completed in accordance with Belzona Know-How System Leaflet FPA-1. The concrete ramp was pressure washed to remove surface contamination before the Belzona 4131 system was applied to the ramp.

This is a common problem on many gas distribution sites across the UK. Belzona was selected firstly for its ability to protect against impact and abrasion. Secondly for being impermeable and resistant to frost damage. After nine years of constant loading and unloading of gas cylinders the loading bay has been revisited in May 2021 and was found to be in excellent condition. The client is very impressed with the Belzona solution provided and has since implemented a variety other successful Belzona applications across their UK sites.
