# Hospital - Air Handler Fan Wheel Shaft Repair With Belzona

ID: 8499

Industry: *Buildings & Structures*  
Application: *FBC-Fans, Blowers and Compressors*

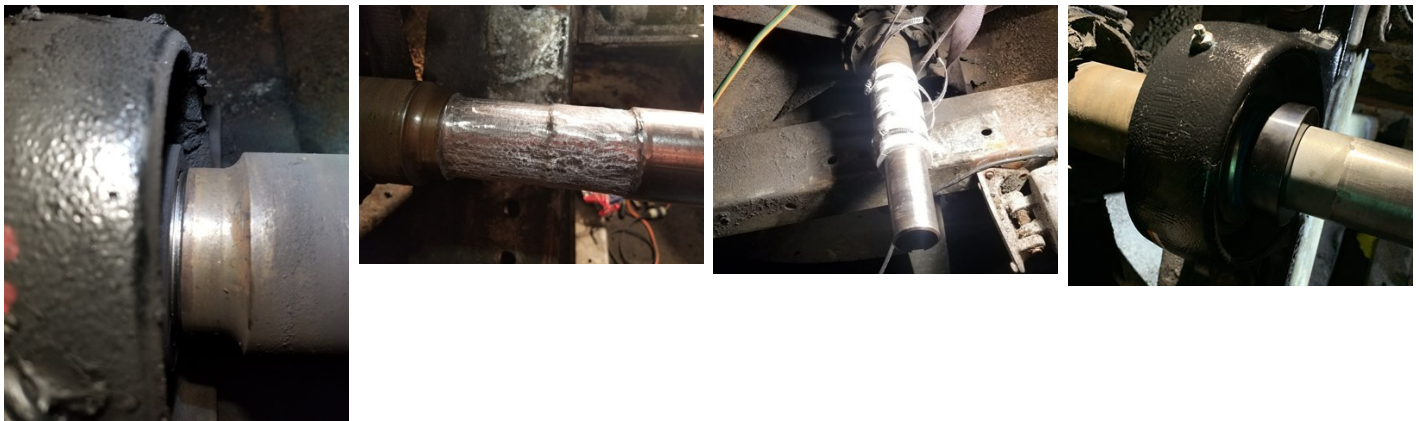
- \* Picture 1 - Shaft damage ,
- \* Picture 2 - Shaft surface prepared ,
- \* Picture 3 - 3D former in place ,
- \* Picture 4 - New bearing in place ,

Air handler pillow bearing ceased and galled a 1/8" groove into the air handler fan wheel shaft.

3D Printed Former was commissioned through Belzona Inc. to the exact tolerances of shaft dimensions. The damaged area on the shaft was undercut and prepared with grinder and file to create ample anchorage point for Belzona 1111. Release agent added to the former surface to aid removal post cure. Material and Former put in place and allowed to follow the initial cure process. Post-cure heating was performed to accelerate the curing process to bring the air handler online as quickly as possible. The former was removed and the material refined and brought into exact tolerance with emery cloth. Post cure heating to 140°F was

completed after 4 hours and the air handler was assembled and put back into service.
