# Hospital - Air Handler Fan Wheel Shaft Repair With Belzona

ID: 8499

Industry: *Buildings & Structures*  
Application: *FBC-Fans, Blowers and Compressors*

Substrate: *Steel Shaft*  
Products: *\* Belzona Shaft Former ,*  
*\* Belzona 9411 (Release agent) ,*  
*\* Belzona 1111 (SuperMetal) ,*

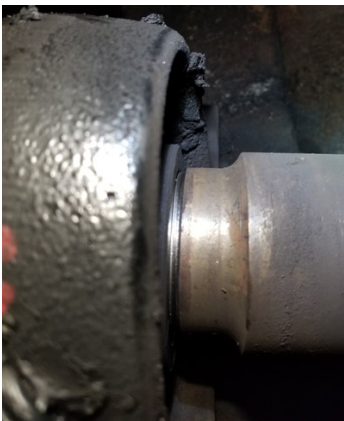
- \* Picture 1 - Shaft damage ,
- \* Picture 2 - Shaft surface prepared ,
- \* Picture 3 - 3D former in place ,
- \* Picture 4 - New bearing in place ,

Air handler pillow bearing ceased and galled a 1/8" groove into the air handler fan wheel shaft.

3D Printed Former was commissioned through Belzona Inc. to the exact tolerances of shaft dimensions. The damaged area on the shaft was undercut and prepared with grinder and file to create ample anchorage point for Belzona 1111. Release agent added to the former surface to aid removal post cure. Material and Former put in place and allowed to follow the initial cure process. Post-cure heating was performed to accelerate the curing process to bring the air handler online as quickly as possible. The former was removed and the material refined and brought into exact tolerance with emery cloth. Post cure heating to 140°F was
