BELZONA RESTORES TWO PUMP IMPELLERS

Industry: General Industry
Application: CEP-Centrifugal Pumps
Substrate: Bronze
Products: * Belzona® 1111 (Super Metal) ,
* Belzona® 1321 (Ceramic S-Metal) ,

Customer Location: Oyster culture, The Netherlands
Application Date: April 2007

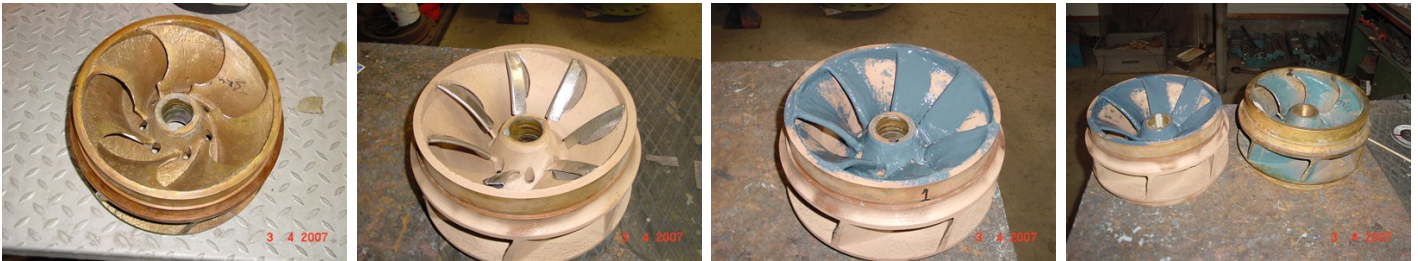
Photograph Descriptions

The two impellers had severe damage because a large bolt was left in the inlet of the pump

- * Damaged impeller ,
- * Stainless steel infill plates ,
- * Belzona® 1111 used to bond plates and restore profiles ,
- * One repaired alongside one still to be repaired ,

Application was carried out in accordance with Belzona Know-How System Leaflets CEP-1 & 3. Steel plates were formed to recreate the lost vanes. Wire mesh was also incorporated into the Belzona rebuild as the original profile was restored. Repair was coated with Belzona® 1321 to give additional smoothness and erosion protection.
