# Pump Diffuser Repaired Using Belzona 1300 Series

ID: 8500

Customer Location: Nova Scotia, Canada  
Application Date: May 2021

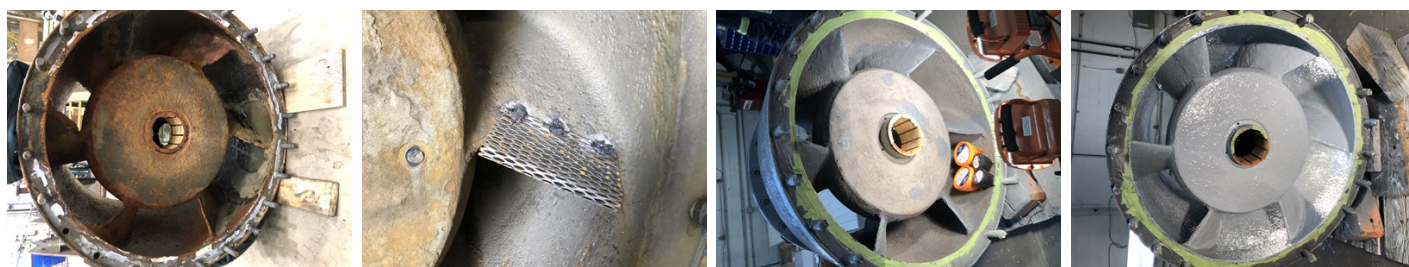
Corrosion and erosion from seawater was causing the leading edge of the diffuser vanes to wear away. Approximately 50 to 75mm of the leading edge was gone when this pump component was taken out for service. Weld repairs were not an option due to the steel alloy material.

- \* 1. Pump diffuser in poor condition on vane leading edges and widespread pitting. ,
- \* 2. Diffuser blasted and steel mesh tack welded into place to support Belzona 1311 rebuilding process. ,
- \* 3. Leading edges of the vanes re-built with Belzona 1311. ,
- \* 4. Diffuser fully coated with two coats of Belzona 1341 Supermetalgilde. ,

The application was carried out in accordance with Belzona Know-How System Leaflet CEP-1 to repair the leading edges of the diffuser vanes, and CEP-3 to line the internal surfaces to protect from the effects of corrosion, erosion, cavitation and provide some efficiency enhancement.
