A Small Hole Can Cause Big Problems, But Belzona Provided The Solution

ID: 8505

Customer Location: Petrochemical Plant - Southeast Texas
Application Date: 05/23/2021

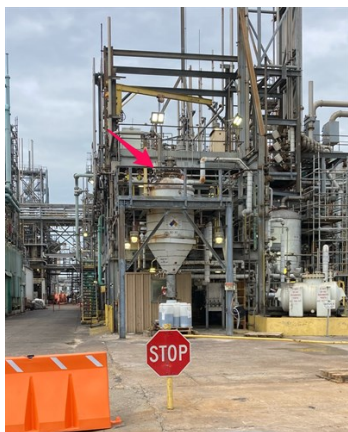
- * 1 - Vessel location ,
- * 2 - Through wall on Weld ,
- * 3 - Finished Job #1 ,
- * 4 - Finished Job #2 ,

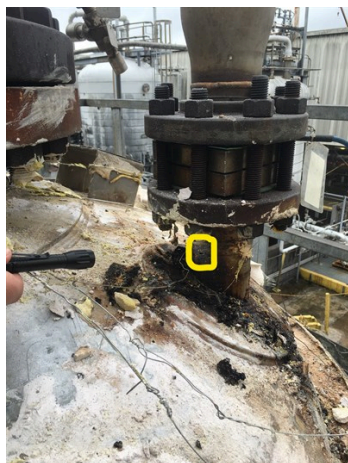
The hole was below the fill line in the carbon steel vessel that was operating at 7-10 PSI with a designed temperature range between 120-140C. The customer needed an immediate solution on a Saturday and within 7 hours of the call a Belzona crew was onsite to repair the nozzle. Plant maintenance had placed a hose clamp with rubber patch over the hole and this was included as a defect in the final repair design.

A hole in a weld developed due to Corrosion Under Insulation on nozzle of an Acrylic Acetate vessel. The plant needed a solution to get them 3-4 months of service until a turnaround without losing any production time.

Application was carried out in accordance with Belzona Know-How System Leaflet VPF-11. The repair area was prepared using spark free vapor blast and tools to clean and roughen the substrate to a near white SSPC SP10 finish. The repair was done in-situ while the vessel was still in operation. Belzona 1511 was used to build up around the hose clamp to achieve a smooth surface for final repair.

Belzona 1392 with a reinforcing cloth was then used to wrap the entire nozzle and onto the vessel body with a final coat of 1392 over the entire repair.
