# A Small Hole Can Cause Big Problems, But Belzona Provided The Solution

**Industry:** Chemical & Petrochemical  
**Application:** VPF-Valves, Pipes and Fittings  
**Substrate:** Carbon Steel  
**Products:** \* Belzona 1511 (Super HT-Metal) ,  
\* Belzona 1392 (Ceramic HT2) ,

**Customer Location:** Petrochemical Plant - Southeast Texas  
**Application Date:** 05/23/2021

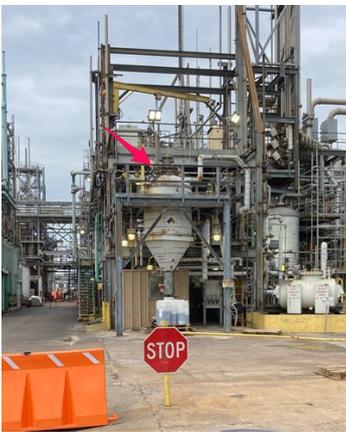
The hole was below the fill line in the carbon steel vessel that was operating at 7-10 PSI with a designed temperature range between 120-140C. The customer needed an immediate solution on a Saturday and within 7 hours of the call a Belzona crew was onsite to repair the nozzle. Plant maintenance had placed a hose clamp with rubber patch over the hole and this was included as a defect in the final repair design.

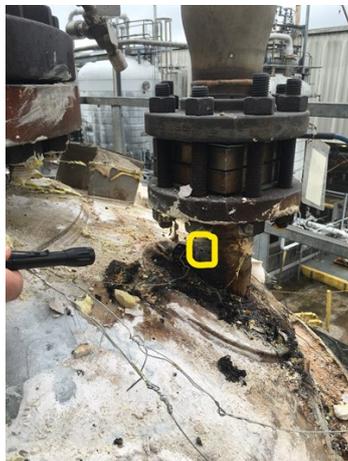
A hole in a weld developed due to Corrosion Under Insulation on nozzle of an Acrylic Acetate vessel. The plant needed a solution to get them 3-4 months of service until a turnaround without losing any production time.

Application was carried out in accordance with Belzona Know-How System Leaflet VPF-11. The repair area was prepared using spark free vapor blast and tools to clean and roughen the substrate to a near white SSPC SP10 finish. The repair was done in-situ while the vessel was still in operation. Belzona 1511 was used to build up around the hose clamp to achieve a smooth surface for final repair.
