BELZONA ELASTOMER VS SAND & WATER ABRASION

ID: 852

Application: SHM-Solids Handling Machinery

Customer Location: Well Servicing Company / Tulsa, OK

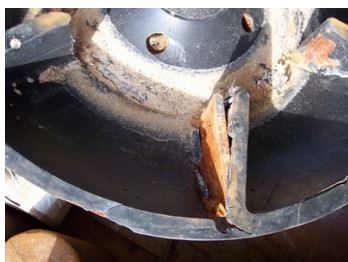
- * Typical wear from Oilwell service caused by sand/water at high pressure ,
- * New prepared slinger being wetted out with Belzona® 2131 ,
- * Mold fitted and filled, waiting cure ,
- * Final step - spin balancing ,

Pumping HP Sand/water slurry down a well includes a Slinger Disc which is lined with a wear material to counter the abrasion.
